**INTERCONTINENTAL TERMINALS
COMPANY, LLC; INTERCONTINENTAL
TERMINALS MANAGEMENT
COMPANY INC.; and CIMA SERVICES,
LP.,**
Defendants.§
§
§
§
§
§
§
§
§
§
§**IN THE DISTRICT COURT OF****HARRIS COUNTY, TEXAS****_____ JUDICIAL DISTRICT****PLAINTIFF'S ORIGINAL PETITION, JURY DEMAND,
AND REQUESTS FOR DISCLOSURE**

**FINAL
REPORT**

CAUSE AND ORIGIN REPORT

Deer Park, Texas | Incident Date: March 17, 2019 | No. 2019-01-I-TX

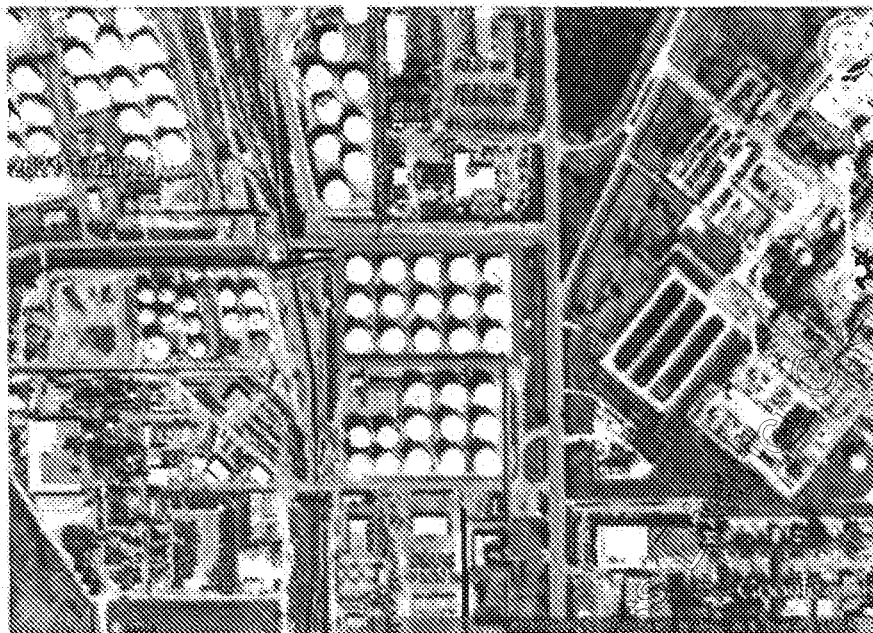
Google Earth Pre-Fire Overview of Intercontinental Terminals Company, LLC

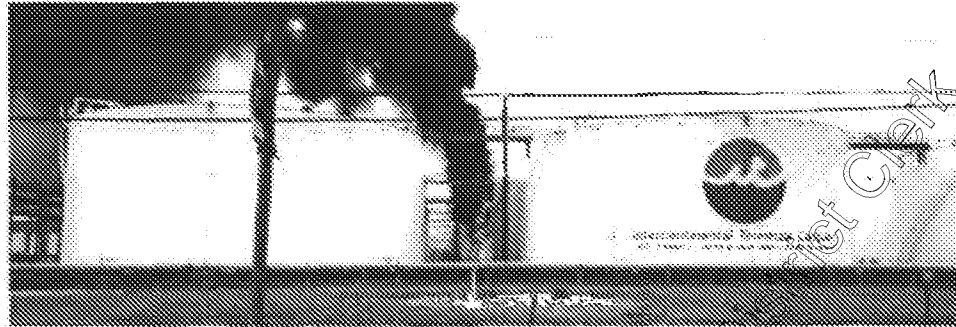
Early Photograph of Fire at Manifold Tank 80-8

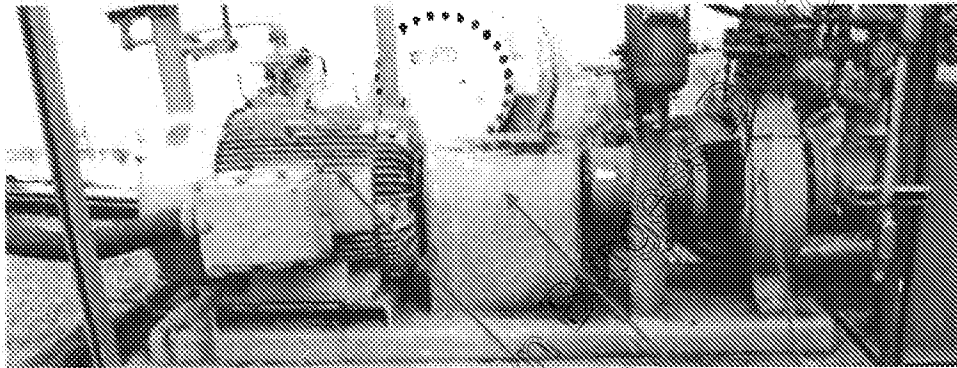
maintenance is conducted, the seal and bearing are provided in a kit supplied by Chesterton®. The surfaces are cleaned but typically not in need of resurfacing. Anti-seize is placed on the connection points. The old assembly is then placed back into the box, which has a label that specifically states "Place Used Seal in This Box". The used kit is then sent back to the company for refurbishing. Various specifications can be assigned to the old parts in need of refurbishing. Typically they require Chemraz® quality as this withstands the exposure to the majority of chemicals the unit will be exposed to. ITC adheres to a "Like-Kind" replacement which means replacing old parts with identical new parts. During the tour, investigators were shown the parts room which contained numerous shelves filled with new parts in boxes and old parts on the shelves mixed in with the new parts. When asked about determining which old parts were sufficient for re-use, Mr. Homfeld stated that decision was done primarily by a visual inspection. In the yard, were numerous power plants, electric motors, pumps etc. that varied from complete units ready for use to parts in need of re-assembly.

Exemplar Power Frame, Electric Motor, Coupler and Pump

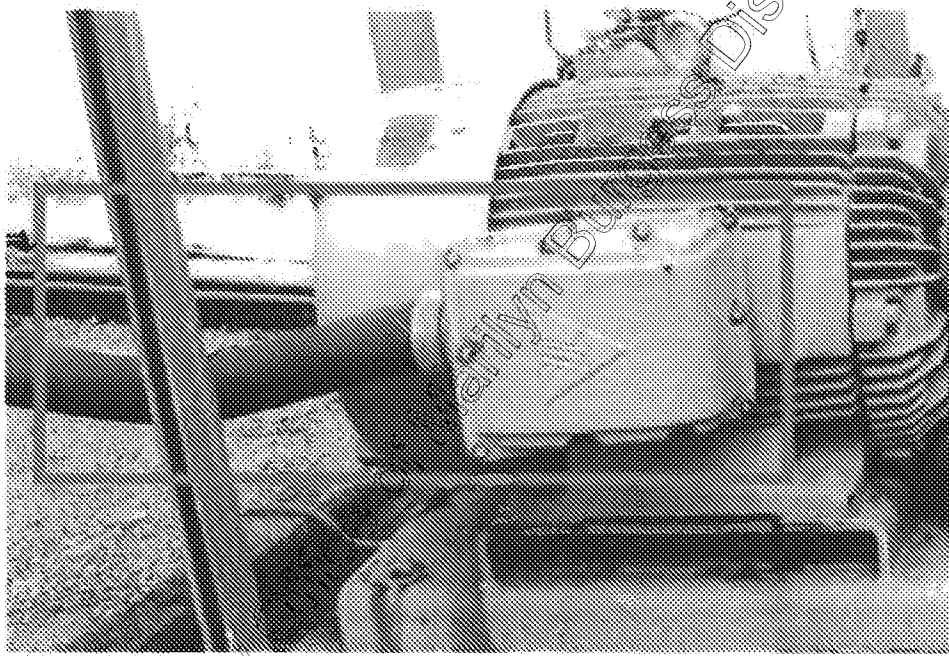
31. Three-phase electrical distribution entered the 80's at the main distribution line near the semi-truck manifold located to the southwest. This also housed the variable 1200 A breakers with 7kv main electrical feed with a transformer bank directly below the main. Electrical distribution was then routed below grade. Where rising out of the earth to connect to the electric motors of the power frames, the conductors were encased in explosion proof housings

Explosion/Vapor Proof Electrical Connection at Motor

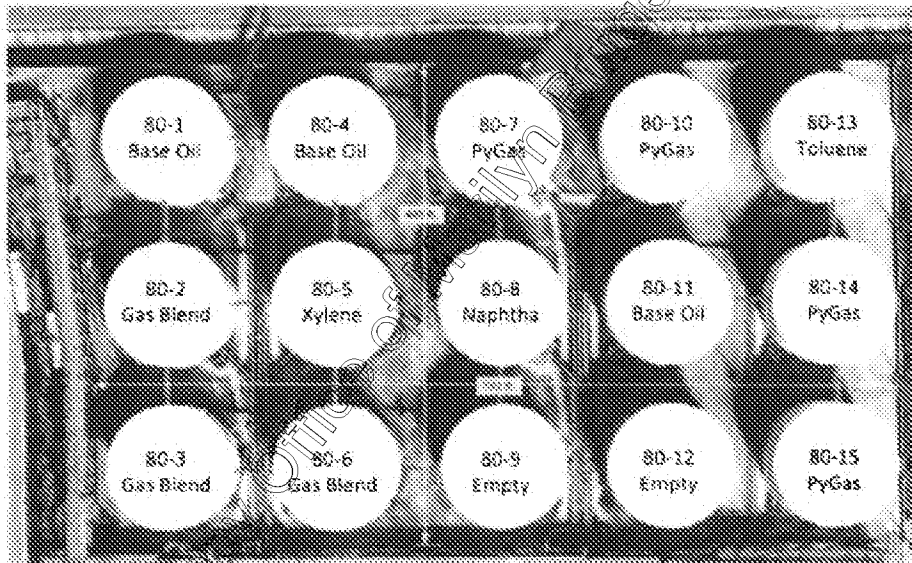
35. There was extensive damage to twelve of the fifteen tanks. Tanks 80-1 (Base Oil) and 80-4 (Base Oil) at the northwest corner of the tank farm were upright without distortion but oxidized from thermal assault. Tanks 80-10 (Py Gas) and 80-13 (Toluene) at the northeast corner of the property were upright, not distorted and retained their white pre-fire appearance. Tank 80-11 (Base Oil) in the second row second tank over from the east was similar to the tanks in the northwest corner. All of the other tanks exhibited oxidation and collapse to varying degrees. Tanks 80-2 (Gas Blend) second row to west and tank 80-6 (Gas Blend) south row second from east were in similar condition to the area of origin tank 80-8. These three tanks exhibited the most severe fire damage and structural collapse to near ground level. There was also no discernable means of analyzing the fire patterns of the tanks alone to explain the fire dynamics of how the fire spread through the tank farm.

Pre-Fire Photo of 80's Tank Farm Labeled with Contents

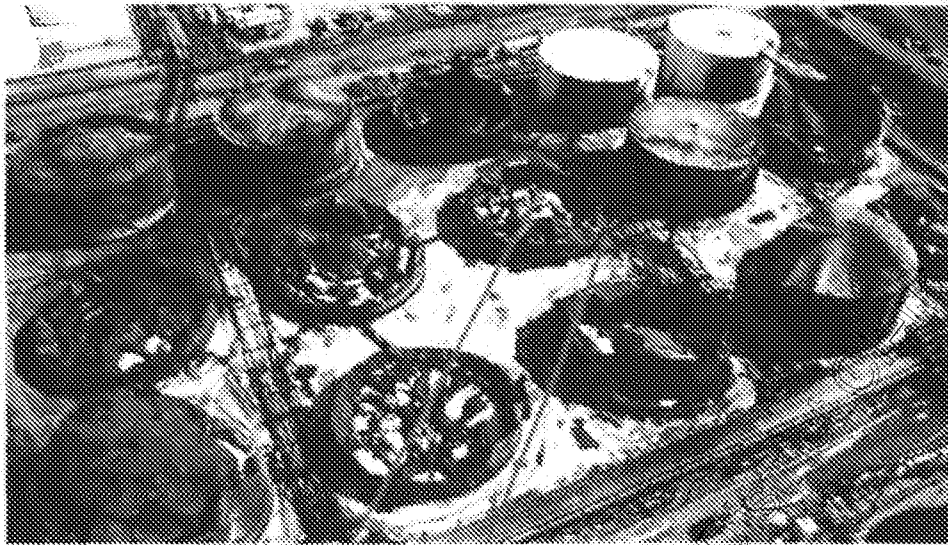
36. Tank 80-8 was the focus of the investigation upon entry. Tank 80-8 was completely destroyed by the fire. The tank exhibited severe oxidation. The steps affixed to the wall of the tank rising upwards to the west, had come loose and fallen to the ground.

Tank 80-8 and Manifold, Origin of Fire

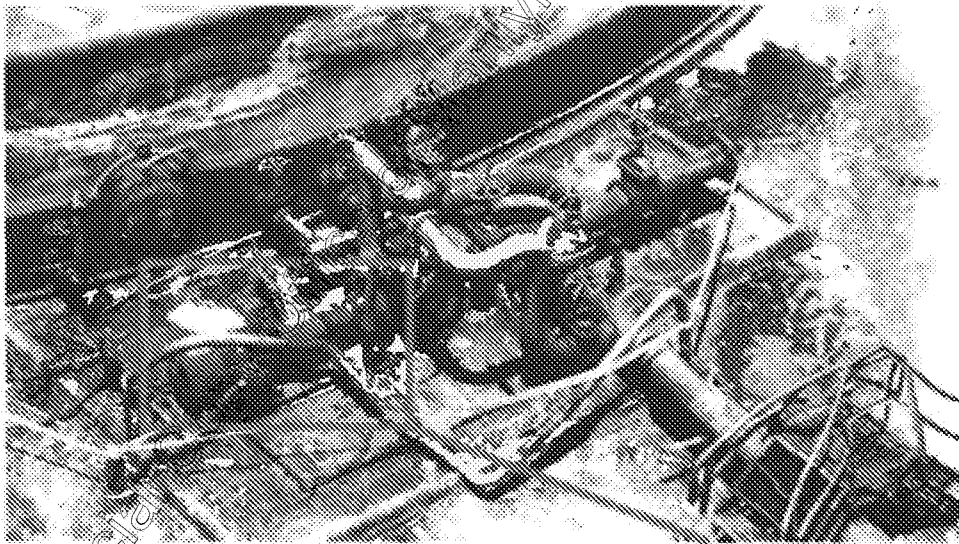
37. The manifold of tank 80-8 was severely damaged. All surfaces exhibited severe oxidation indicative of long term thermal exposure. The damage observed is described from left to right while facing the tank and manifold with the power frame noted first.

Overview of Tank 80-8 Manifold and Power Frame

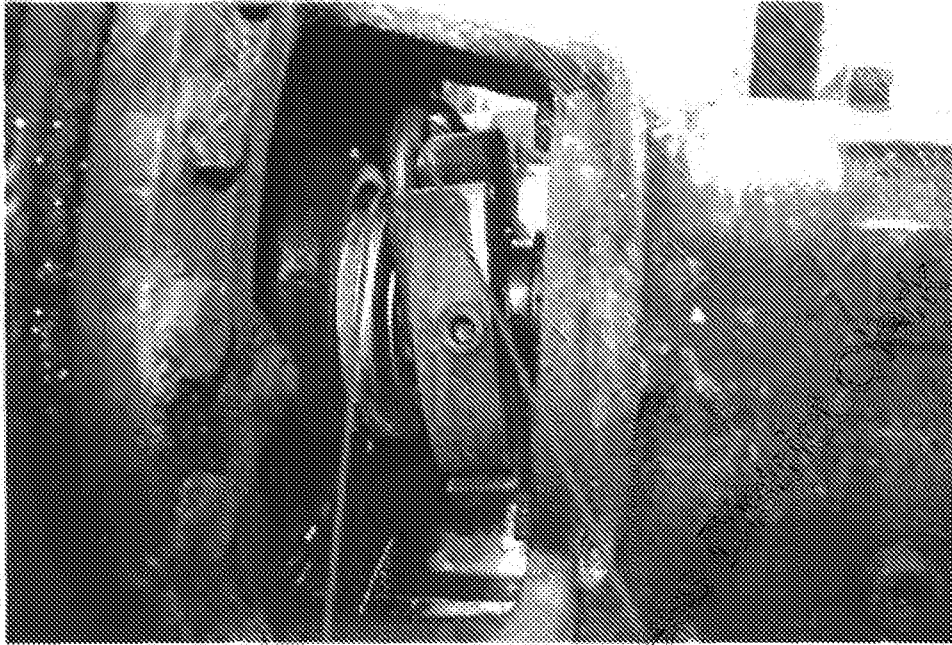
39. The metal coupler cover between the pump and the electric motor was askew but not oxidized like all of the other metal in the manifold. An attempt to lift the coupler protective housing was not successful as there was still at least one bolt securing it to the skid. The cover was left in place. Just past the cover was the shaft into the pump. The seal pot on the shaft was dislodged and resting at an angle away from the pump. The coolant supply and seal pot return lines had been mechanically sheared from the coolant tank and wrapped around the seal pot and shaft. This indicates that the motor had been working and the shaft was revolving shortly before ignition.

Dislodged Seal Pot and Bent Coolant Supply Lines

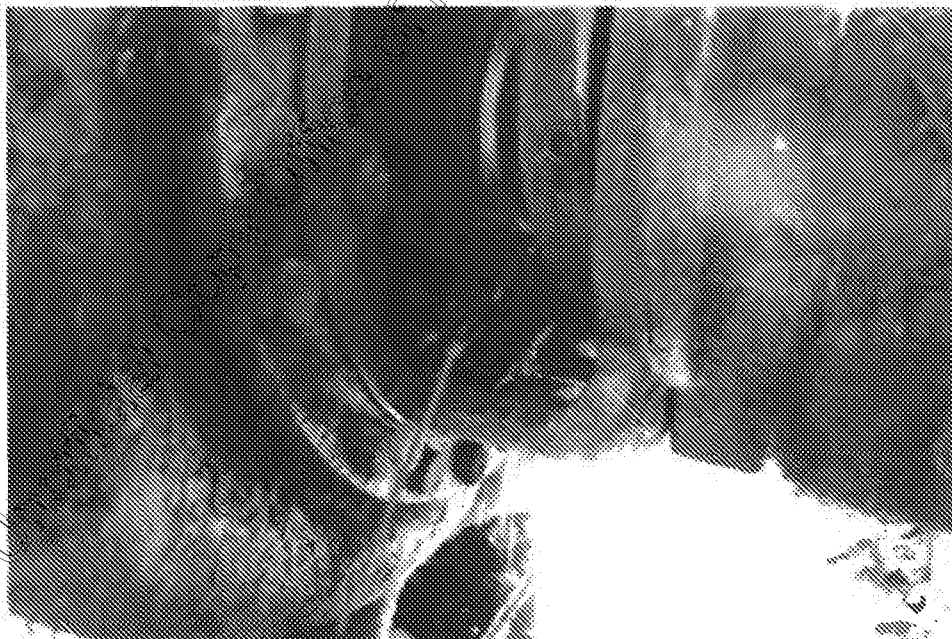
40. There were no nuts visible on the studs to secure the seal pot in place. The studs themselves appeared to have worked loose and were resting in the housing below the shaft. Because of the limiting factor of the hazardous materials personal protective/safety equipment, it could not be determined if the nuts worked free during operation or if they were sheared off when the seal pot came loose.

Seal Pot Mounting Studs Worked Loose from Mounting Surface

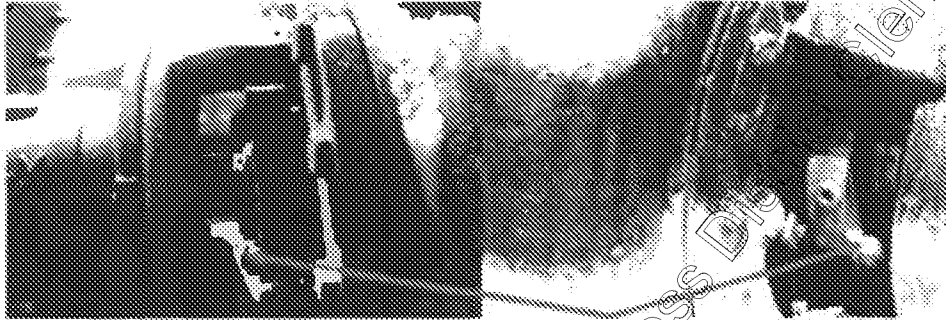
44. Other power frames and manifolds within the tank farm were examined as comparisons to tank 80-8. The power frame and manifolds at tank 80-7, 80-10 and 80-11 were viewed and documented. These units did sustain some thermal damage and exhibited minor to moderate oxidation but nowhere nearly as severe as tank 80-8. The electric motor housings were not cracked. There was no misalignment of the pump shafts. The shafts were all properly inserted into the pump housing. The coolant system, seal and bearings were all in place with the coolant supply and return lines properly routed and affixed to the oil tank. The nuts and studs were in place. All piping and valves of the manifolds were intact without any misalignments, separations or consumption. There was no debris field below the coupler and pump as was at tank 80-8.

Close Ups of Seal Pots on Fire Damaged Pumps with Studs in Place.
Note Left Has Studs Extended Past Nut and Right Does Not

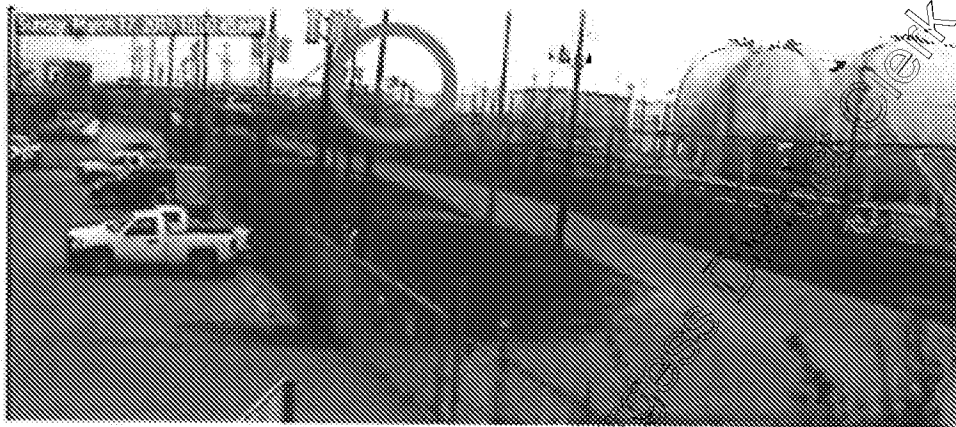
54. Surveillance video was provided by ITC. The footage provides a time stamp of March 17, 2019 at 10:00:45 hours. It reveals the initial fire growth.

ITC Video Capture

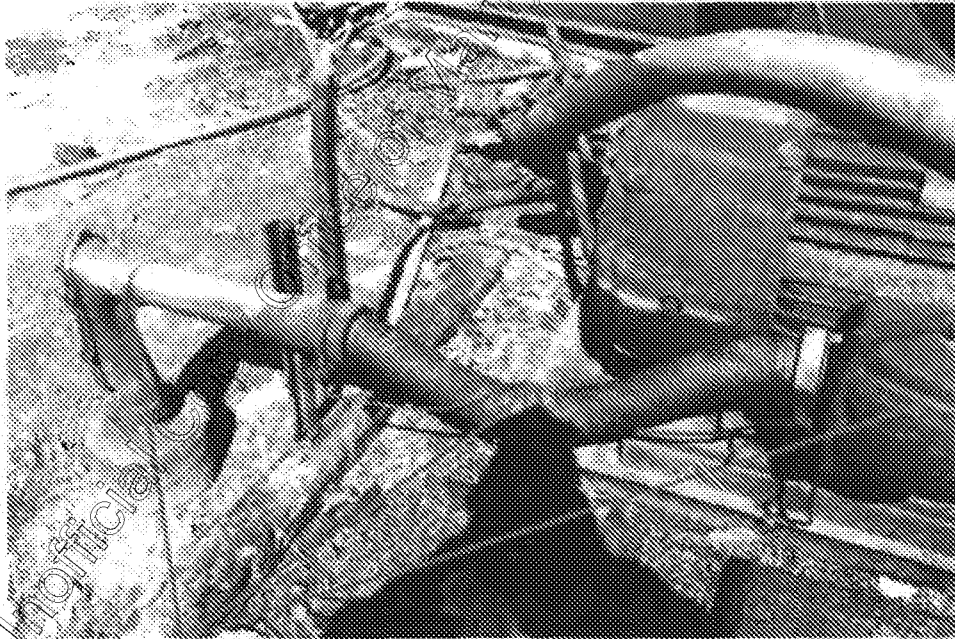
86. The electrical distribution entrance to the 80's was at the south side near the truck manifold. Branch circuits were routed through underground conduit. All electrical service was contained in explosion/vapor proof housings. The only electrical connection at any given manifold was at the electric motor of the power frame. The large conduit and covering for the electric motor of 80-8 remained intact and with only minor thermal damage. The fire was not caused by a failure of the electrical distribution system up to the electric motor of the power frame.

Electrical Connection from Underground to Power Frame 80-8 Remains Intact Post-Fire

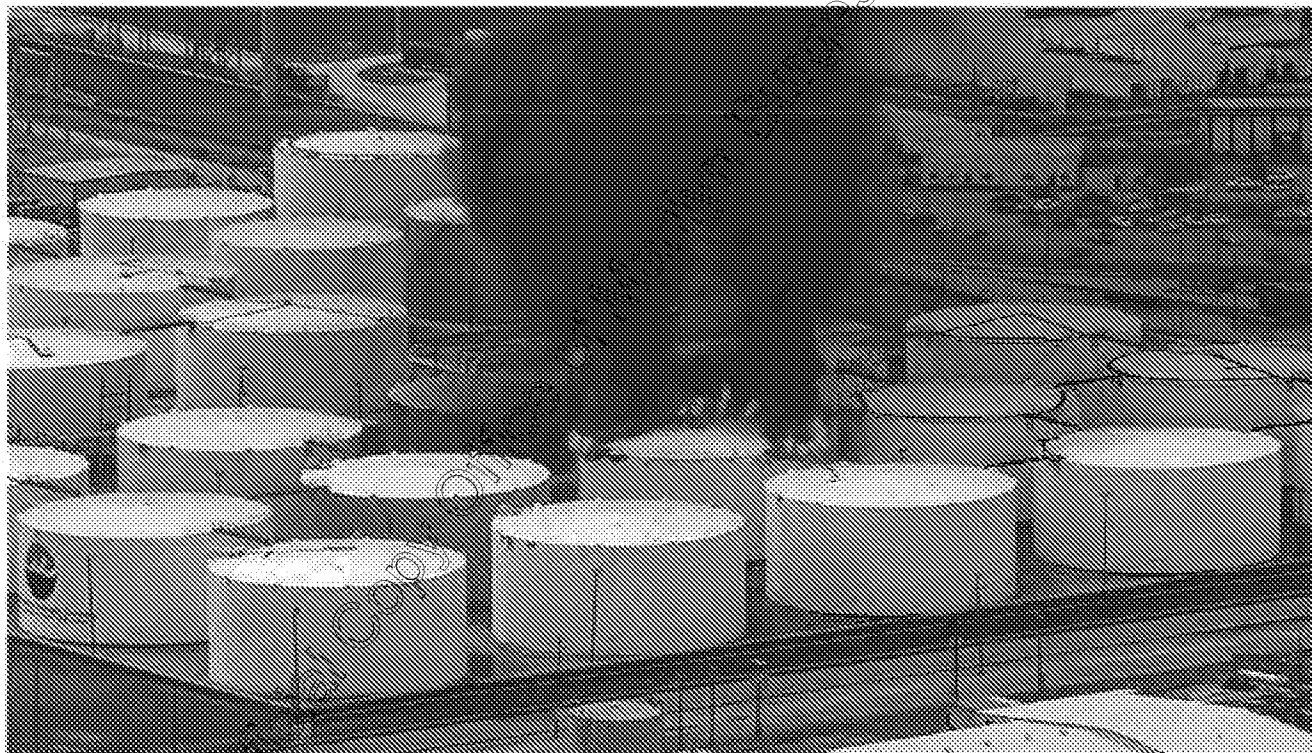
Figure 1. ITC Fire. This photo shows the ITC fire involving tank 80-8 on March 17, 2019. (Source: ABC13 Houston).

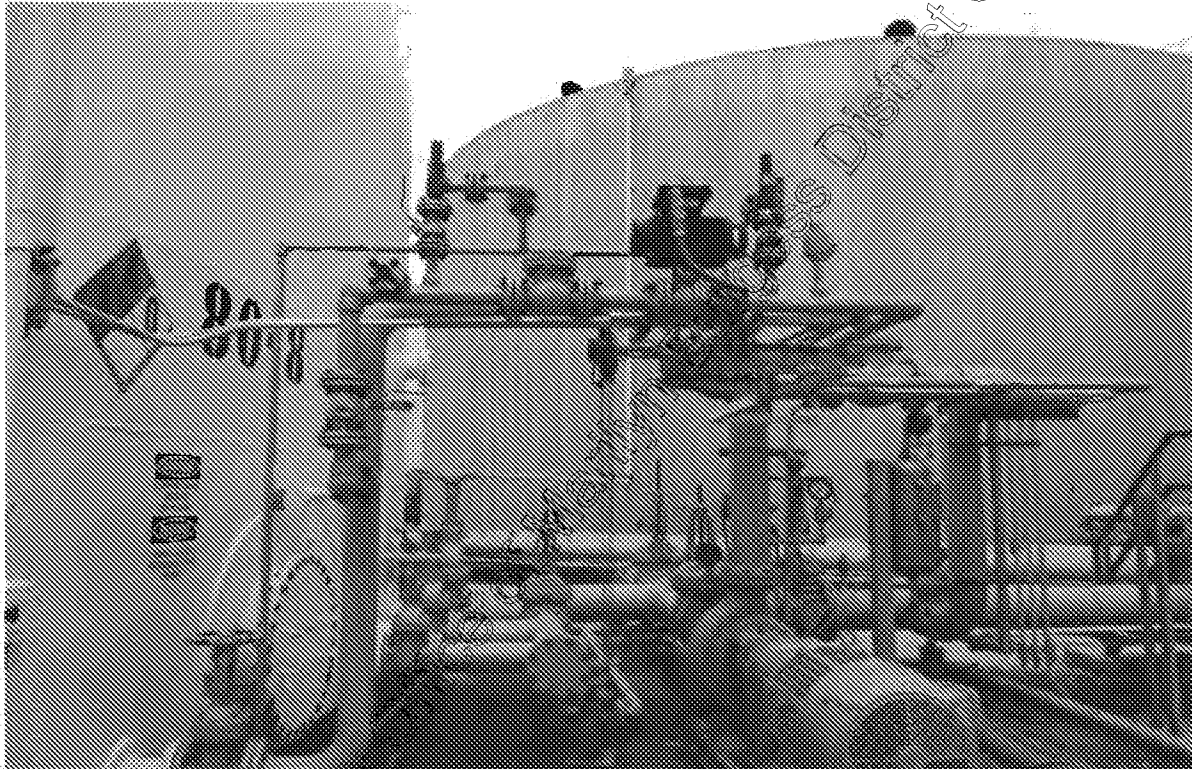
Tank 80-8 was an 80,000-barrel aboveground atmospheric storage tank. The tank went into service in 1972 and was original to the ITC Deer Park Terminal. Tank 80-8 was leased to another company for naphtha storage and for naphtha-butane blending operations. ITC injects butane into the naphtha product using external piping and equipment (piping manifold) (**Figure 3**) to increase the octane level of the fuel product.

Figure 3. Tank 80-8 Piping Manifold. This image taken before 2016 shows Tank 80-8 and its piping manifold. (Source: ITC).

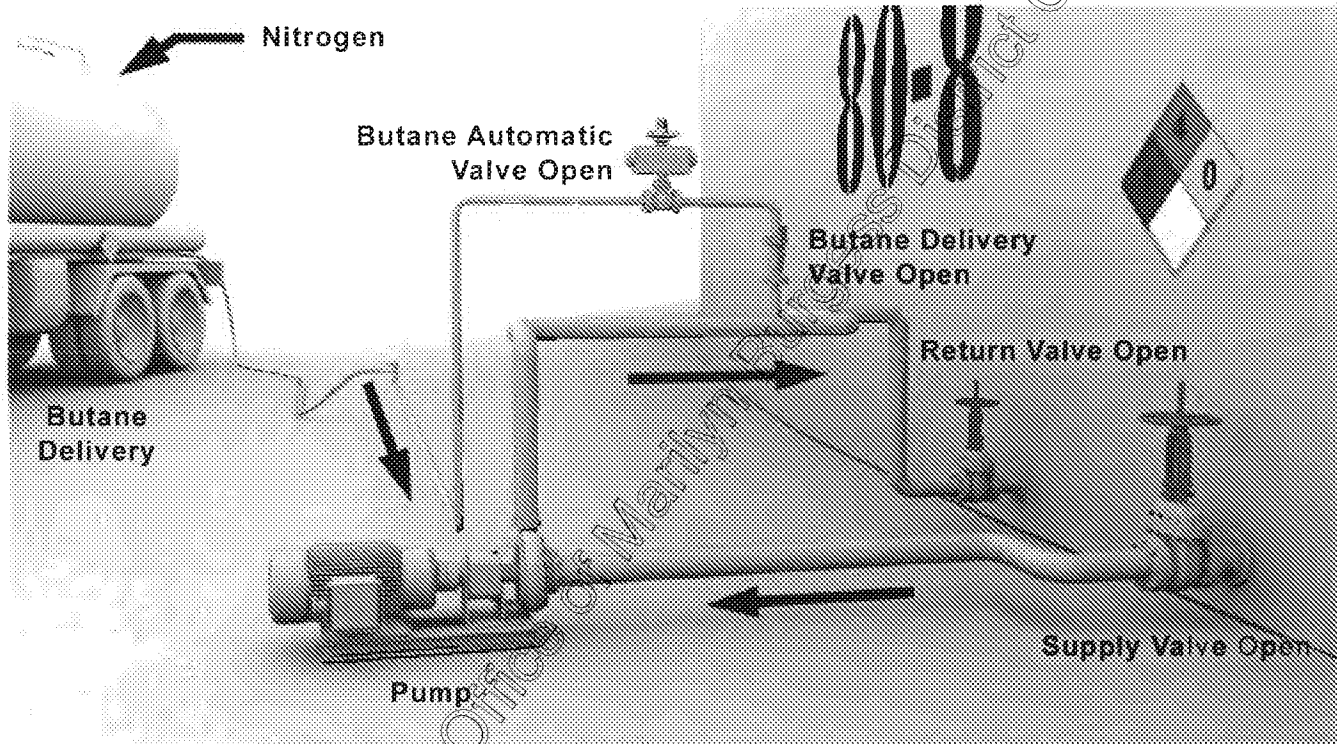
Figure 4. Simplified schematic showing ITC's butane blending system. The arrows in the figure show the butane flow direction and the naphtha product circulation path through the piping. (Source: CSB).

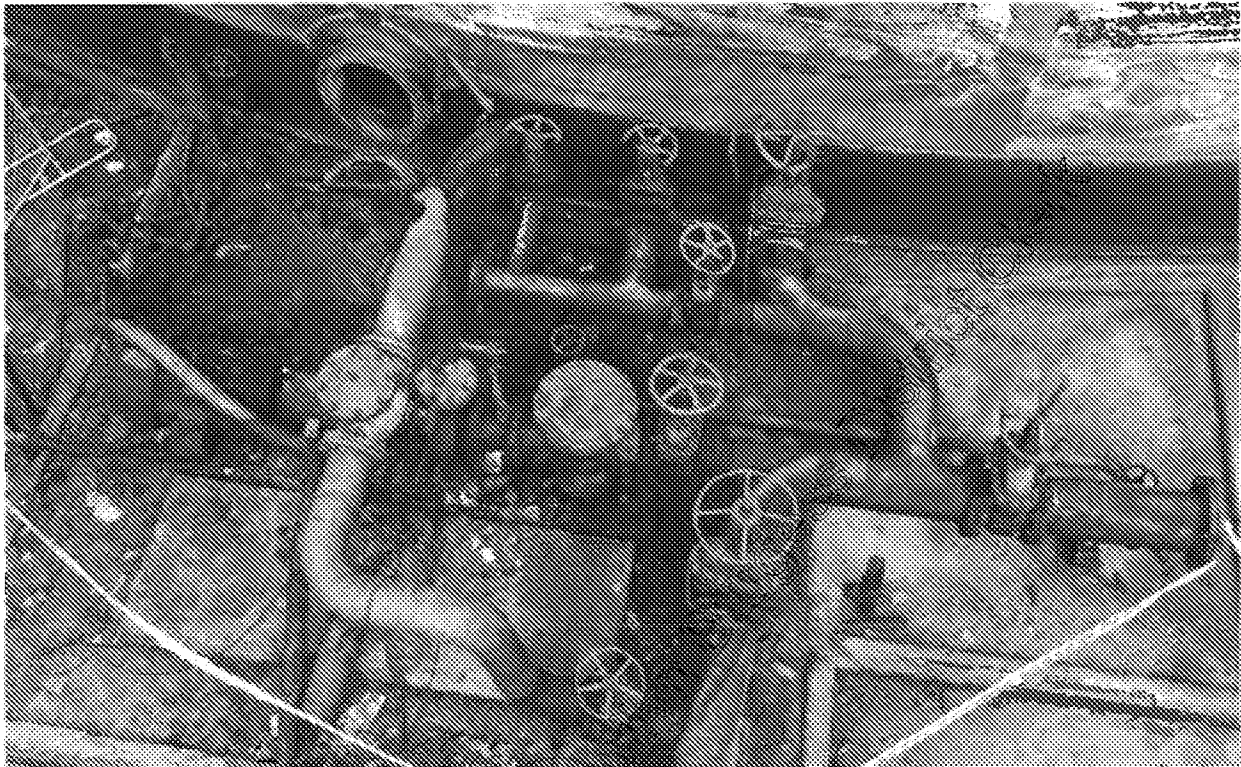
At approximately 10:00 am, a large fire erupted in the vicinity of the Tank 80-8 piping manifold (**Figure 5**). Shortly thereafter, at 10:01 am, control system event logs indicate that the pump shut down, and then the Tank 80-8 equipment lost communication with the DCS. No further control system data for Tank 80-8 or the pump were available after this time.

Figure 5. Tank 80-8 Piping Manifold. This photo shows the post-incident condition of the Tank 80-8 piping manifold. (Source: ITC).

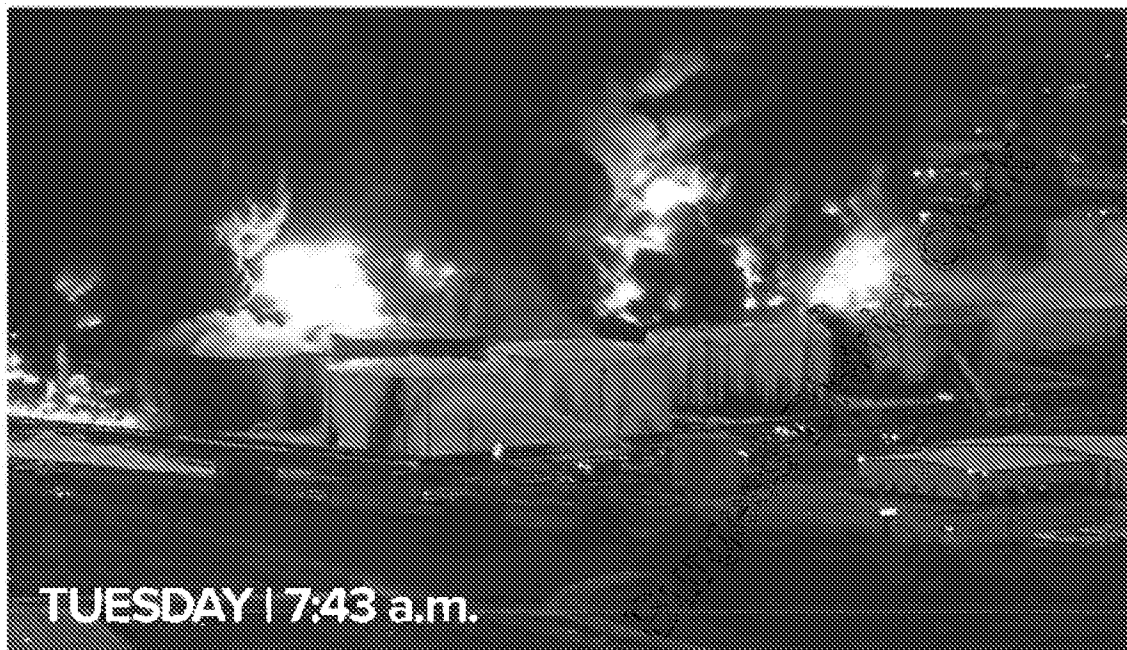
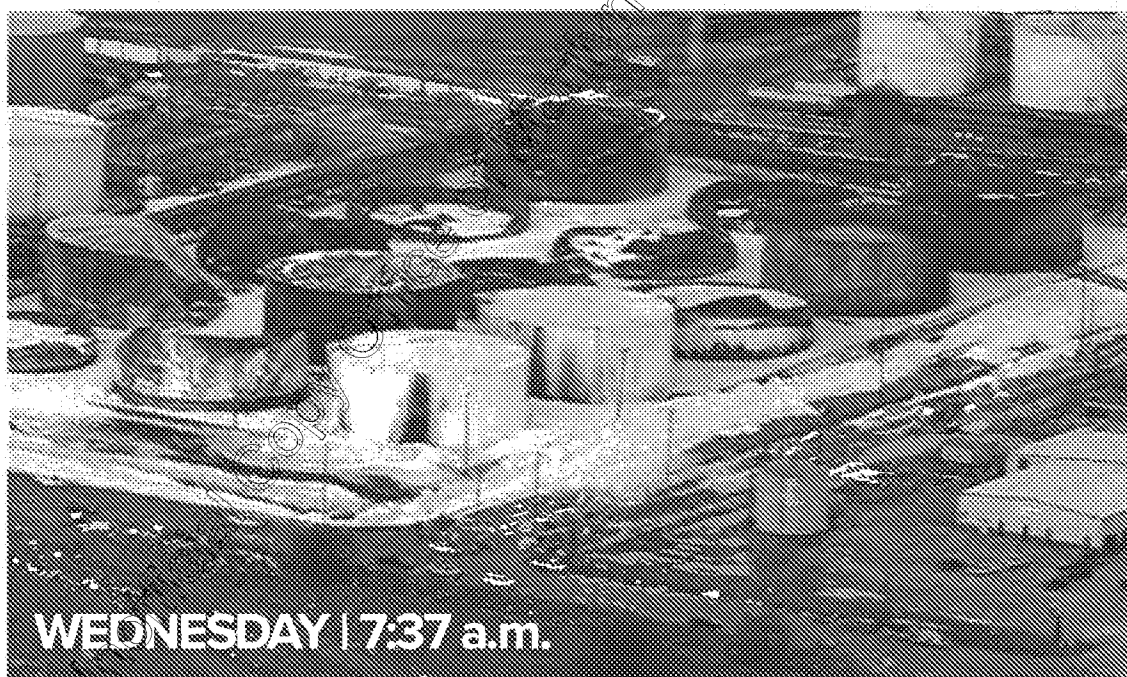
Figure 7. First & Second 80's Tank Farm. This photo shows the fire raging on Tuesday, March 19, 2019, and fully extinguished on Wednesday, March 20, 2019. (Source: KHOU 11 News).
